# Analysis of the Line of Duty Death of Firefighter Nathan Flynn Utilizing Fire Dynamics Simulator, Fire Testing and Electronic Data Sources

7005 Woodscape Drive, Howard County, MD

Incident Date: July 23, 2018

**ATF BALTIMORE FIELD DIVISION**

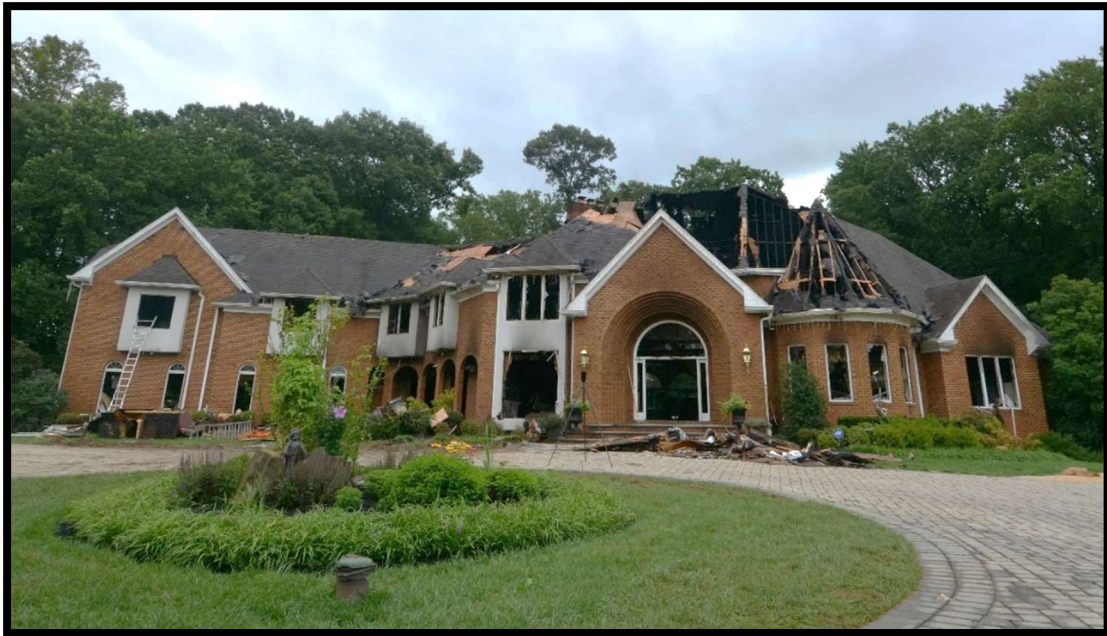
**Figure 1. A front view (side A) of 7005 Woodscape Drive. The large single-family residence included approximately 8,400 square feet of finished living space.**

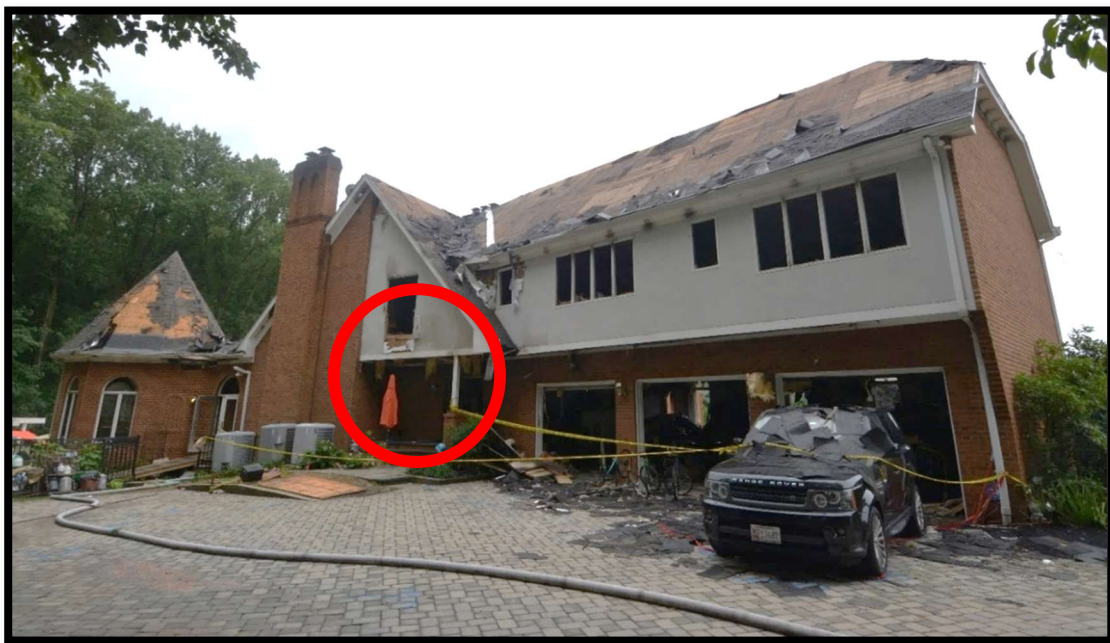
**Figure 2. An overall view of the North side (upper side C) of 7005 Woodscape Drive. Upper side C consisted of an at-grade entrance to a mud room/kitchen as well as a three-car garage. Firefighter Flynn utilized this upper side C entrance (indicated with a red circle) to initiate fire attack on the first floor just prior to falling into the burning crawl space below.**

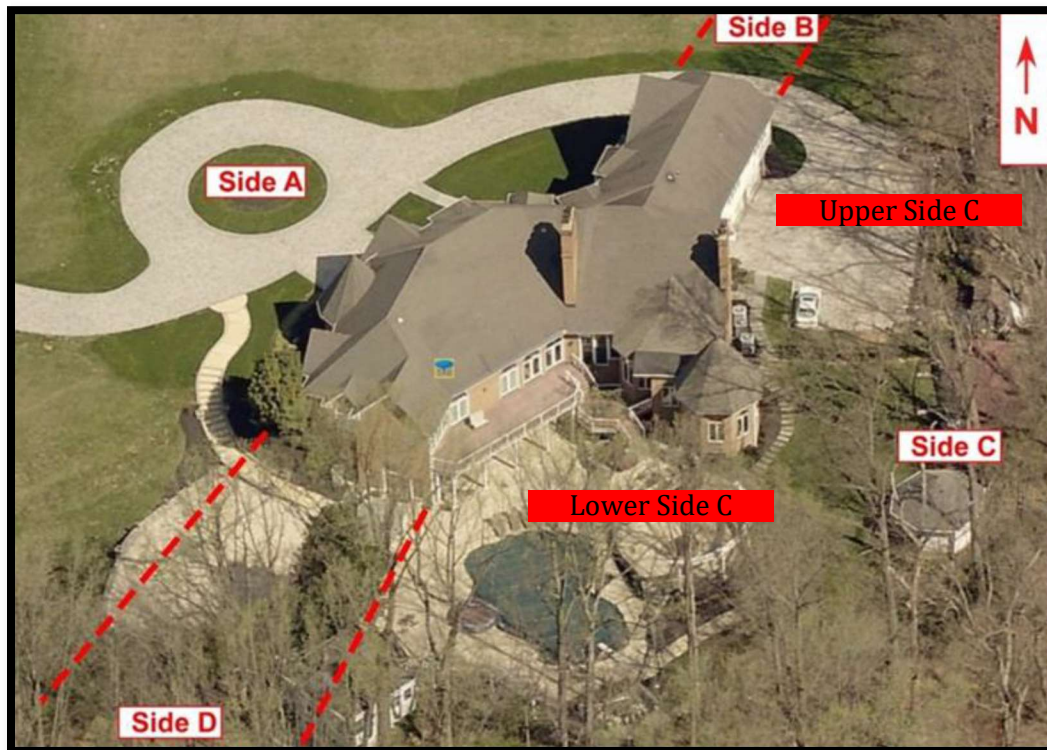
Figure 3. An overall aerial view of the rear (upper and lower side C) of 7005 Woodscape Drive. Sides B, C and D are also labeled.

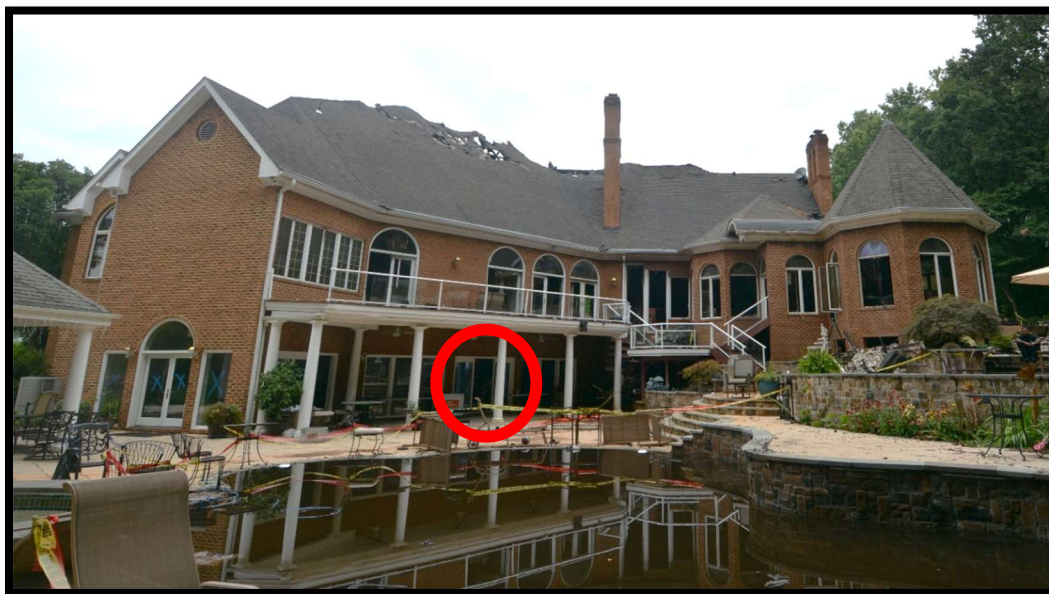
Figure 4. An overall view of the lower side C (rear) of 7005 Woodscape Drive. Lower side C consisted of at-grade access to the basement, an elevated deck accessing the first floor and a large, in-ground swimming pool. The pool was utilized as a secondary water supply in addition to a municipal water supply relay from a distant hydrant. The at-grade entrance into the basement is circled.

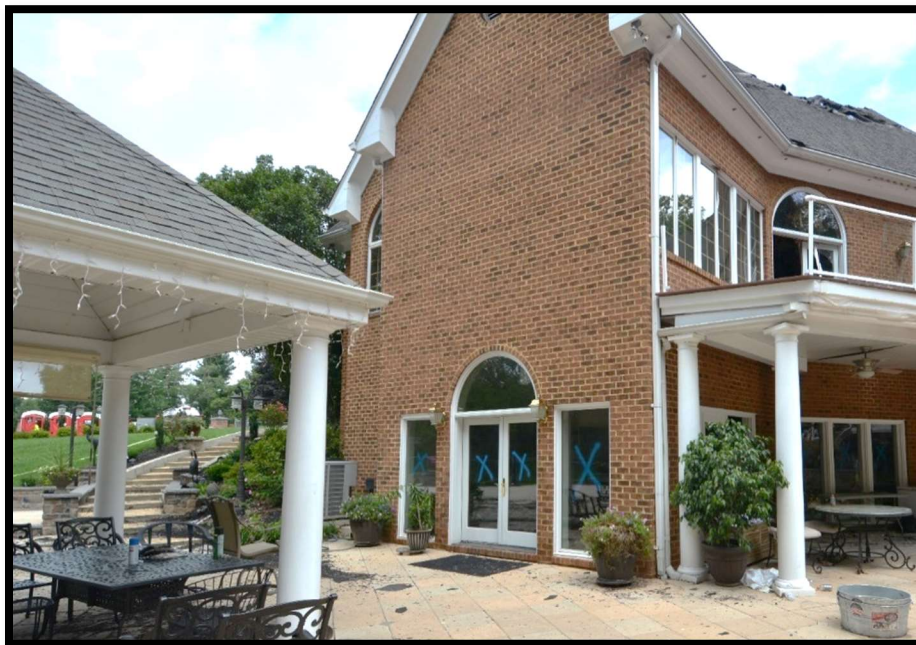
**Figure 6. An overall view of the south side (side D) of 7005 Woodscape Drive. At-grade access to the basement existed towards the rear and the terrain increased to the level of the first floor as one approached side A.**

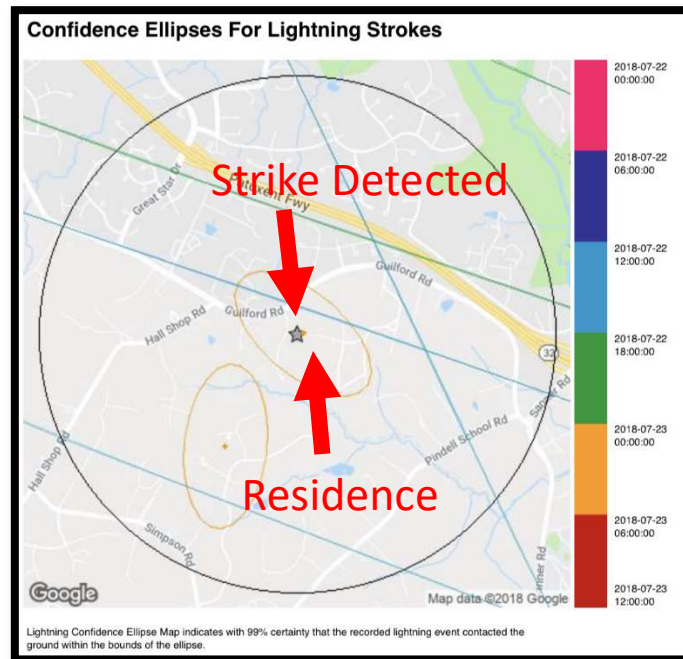
**Figure 13. StrikeNET ellipse map detailing location of 7005 Woodscape Drive, the nearby detected strike (star) and the confidence ellipse detailing with 99% certainty that the strike occurred in the bounds of the ellipse. The location of the residence is represented as the green star.**

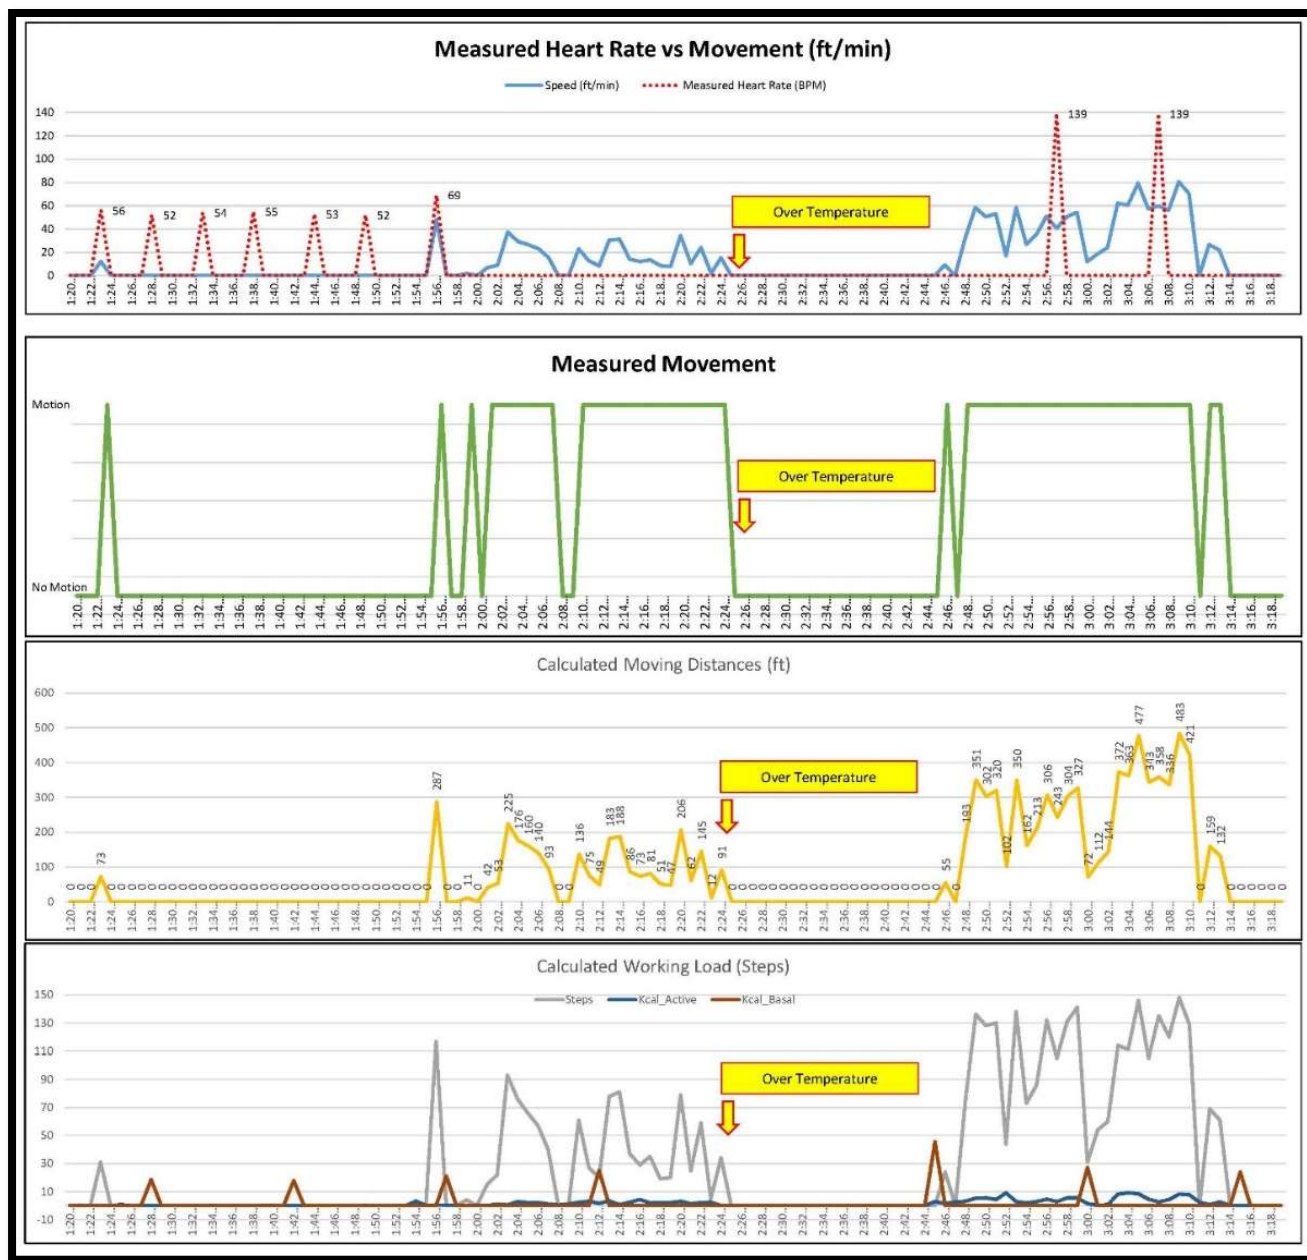
**Figure 16(a).** Visual representation of data recovered from Firefighter Flynn's Apple Watch including movement, heart rate, estimated distance and over temperature. This data was compared to other forensic data recovered from the SCBA and portable radio to gain a better understanding of Firefighter Flynn's movement both before and after the MAYDAY.

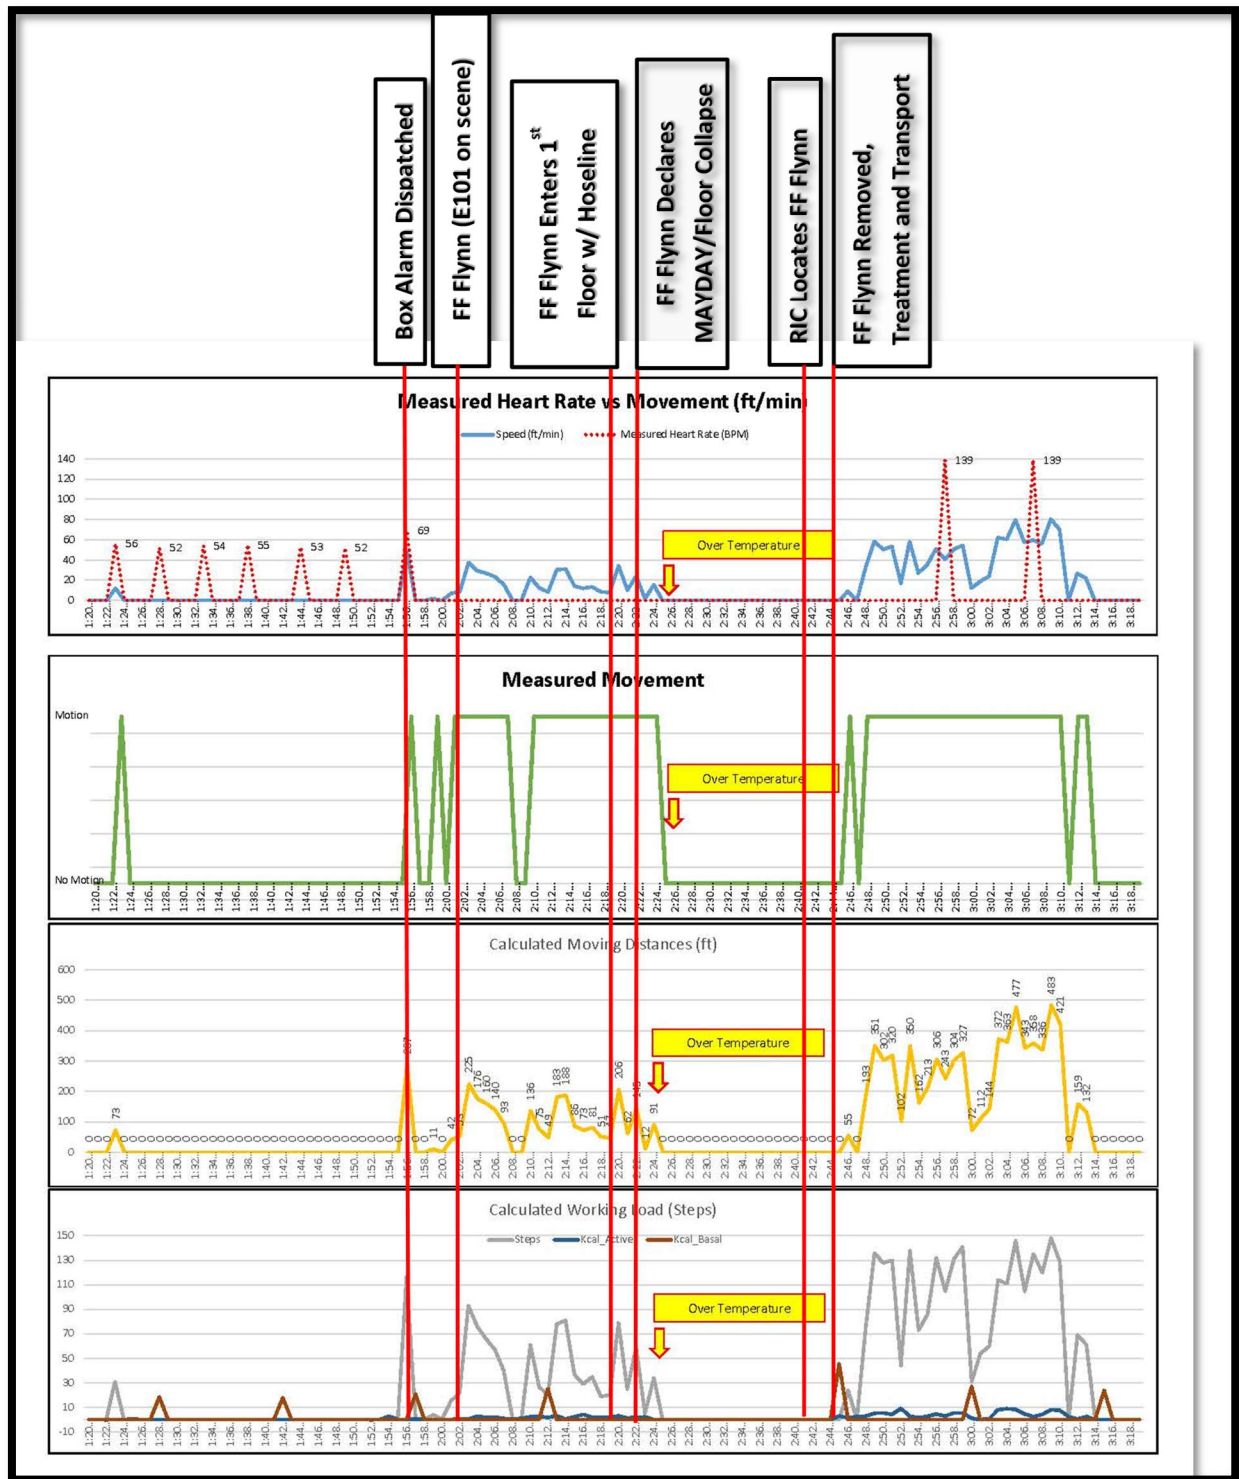
**Figure 16(b). Visual representation of data recovered from Firefighter Flynn’s Apple Watch with event timestamps overlayed. The Apple Watch was unable to record additional data during the over temperature fault, however data recording resumed after Firefighter Flynn was removed from the crawl space by the RIT members and the ambient temperature decreased.**

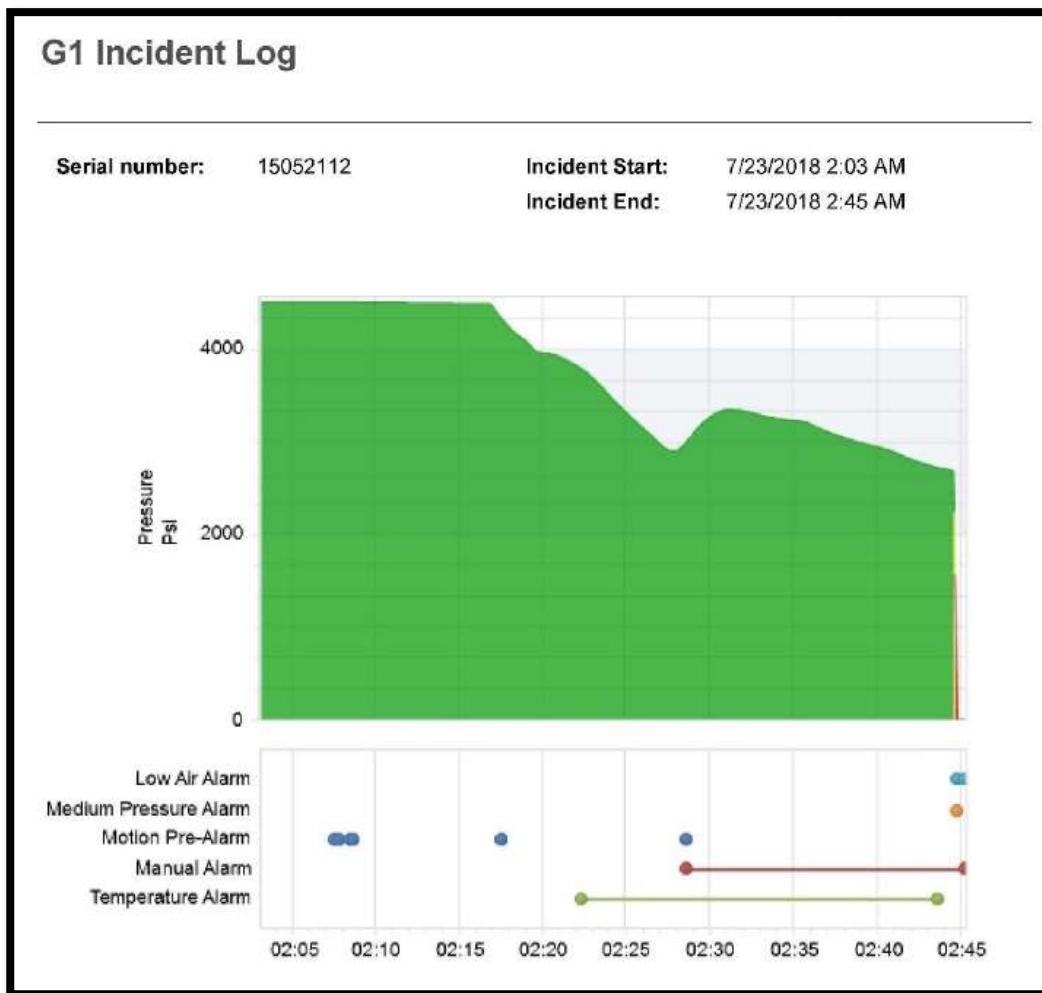
**Figure 17(a). Self-Contained Breathing Apparatus (SCBA) visual event log for Firefighter Flynn including air pressure profile, air consumption rate, motion data, presence of SCBA alarms (temperature alarm, low air alarm, motion pre-alarm, manual Personal Alert Safety System (PASS) alarm activation) and event time. In this event, Firefighter Flynn’s SCBA temperature alarm also corresponded with a consistent increase in air pressure in Firefighter Flynn’s air cylinder at approximately 2:27 AM and lasted for about 4 minutes. This increase in air pressure was associated with rapid environmental heating of the SCBA just after Firefighter Flynn fell into the burning crawl space and called his MAYDAY.**

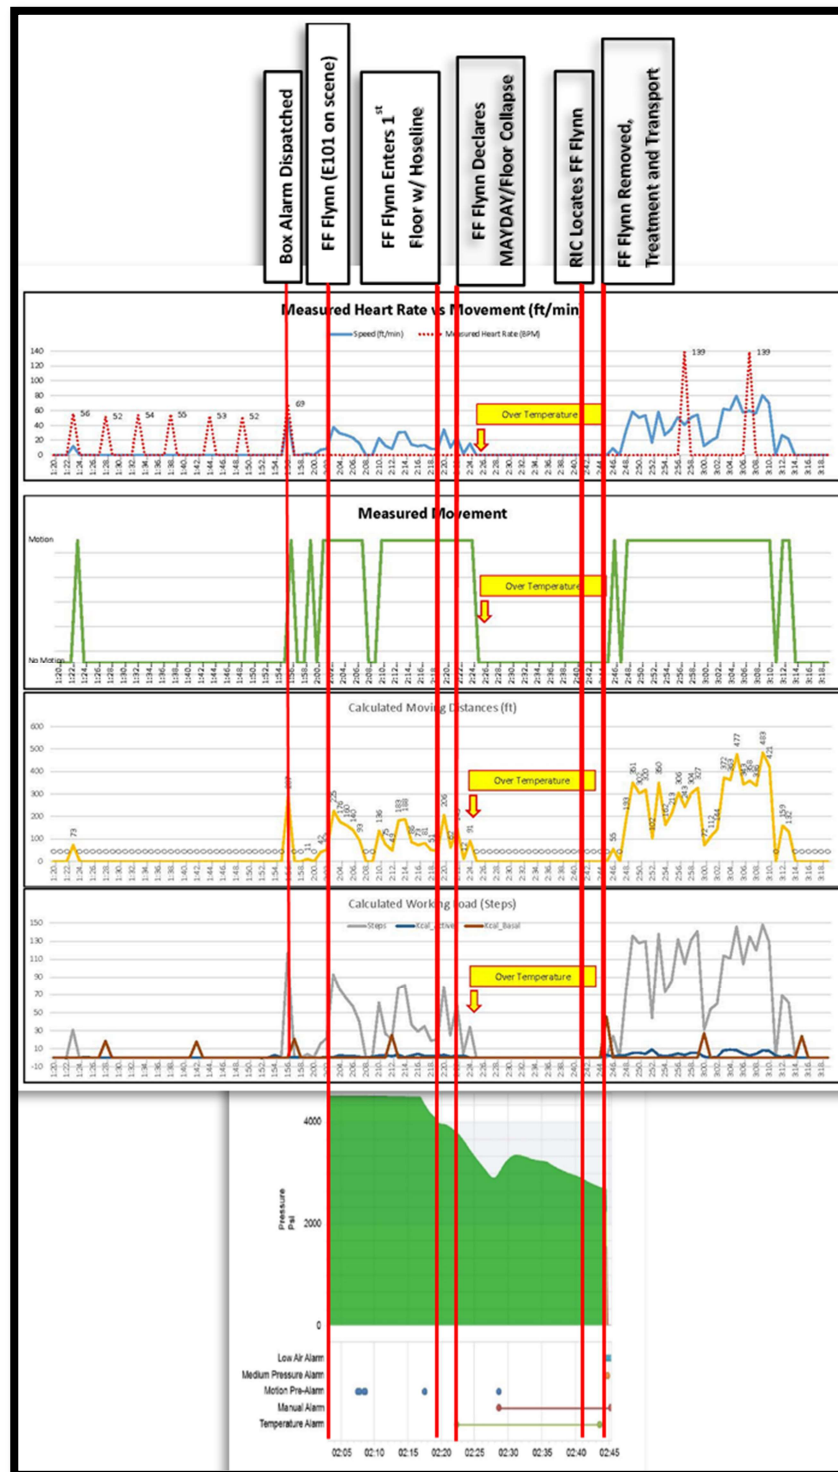
**Figure 16(c). Overlay of Self-Contained Breathing Apparatus (SCBA) visual event log and Apple Watch visual representation of electronic data for Firefighter Flynn with event timestamps synchronized. The Apple Watch over temperature and SCBA temperature alarm both activate once Firefighter Flynn falls into the crawl space and declares a MAYDAY. Movement data and air consumption rates are also included.**

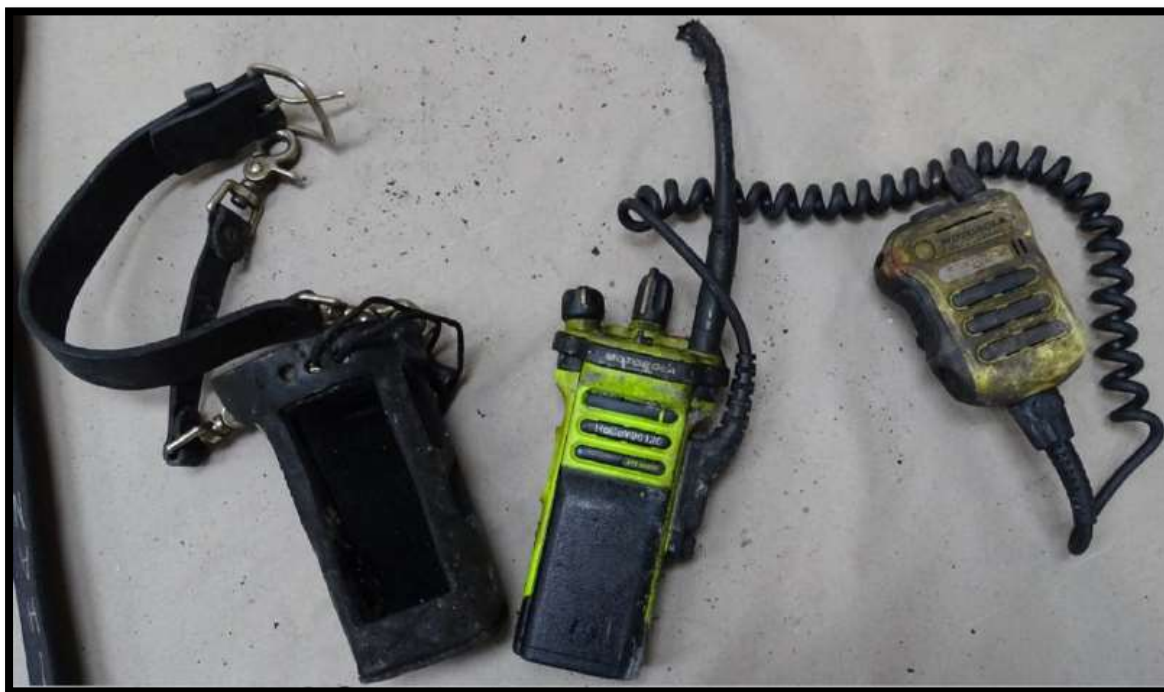
**Figure 18. Motorola APX8000XE portable radio possessed by Firefighter Flynn throughout the incident. Forensic data was recovered from the radio and radio system, including the channel selected by the portable radio, all audio communications on all radio talk groups, the presence of the automatic "man-down" motion activated emergency alert feature and any manual emergency button alarm activation. The radio was located underneath, and protected by, Firefighter Flynn's turnout coat throughout the incident.**

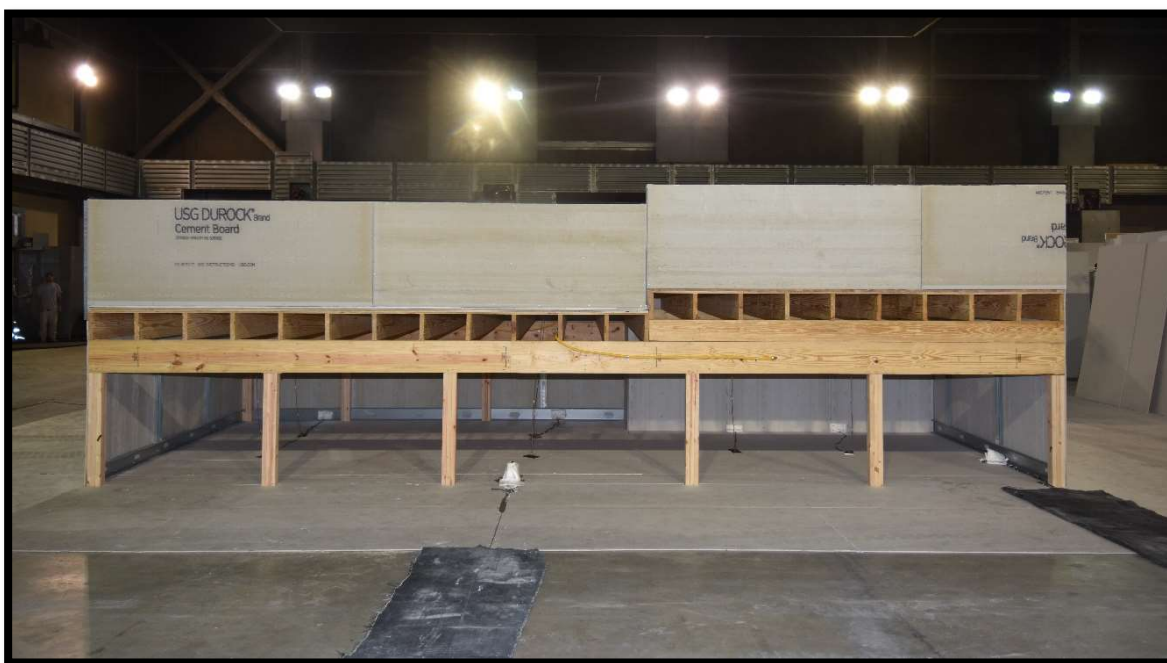
**Figure 25. ATF Fire Research Laboratory large-scale testing structure based on several data sources collected at the scene. The structure was built based from original construction documents and included the crawl space (below) and the living room floor support structure above.**

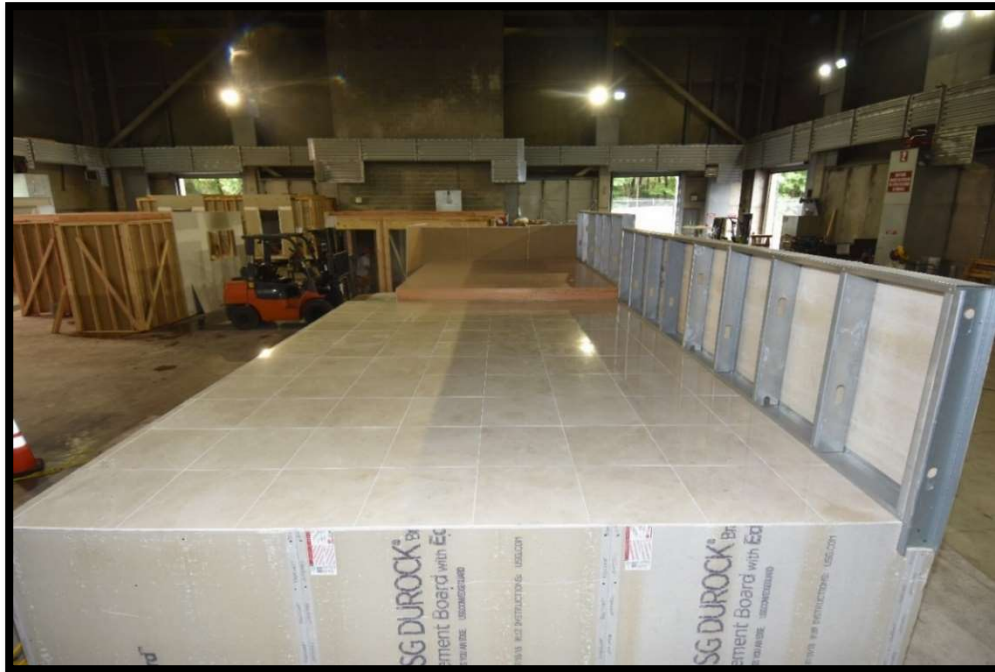
**Figure 26. Top view of the large-scale testing structure. The flooring construction methods were also based on the original construction drawings, including two layers of Oriented Strand Board (OSB), non-combustible Italian tile on top of tile backing, all supported by 2 X 10 floor joists.**

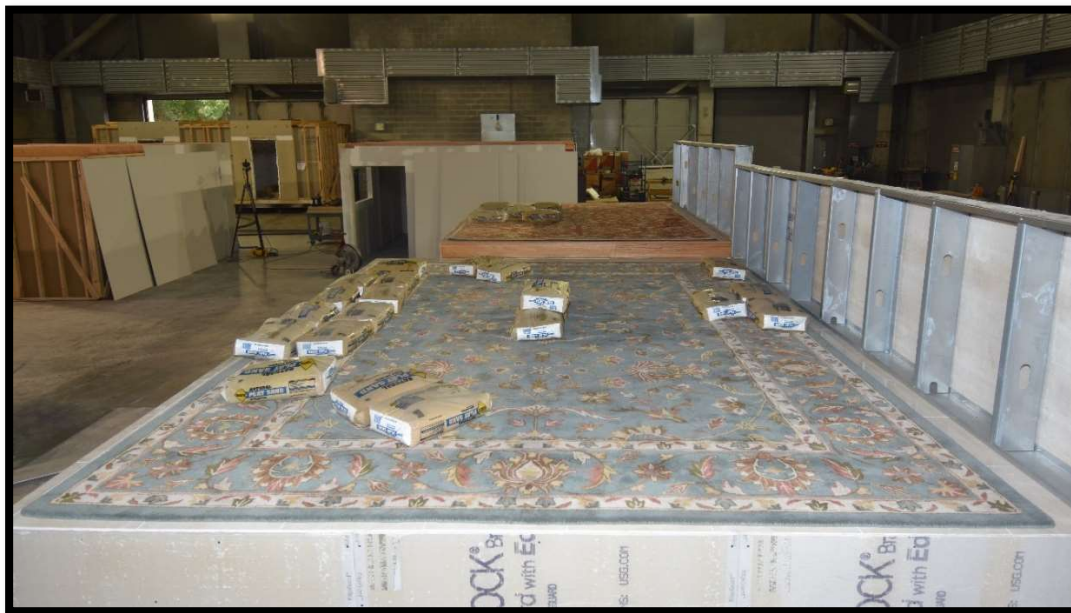
**Figure 27. Large wool area rugs based on the material composition of rugs located in the living room of the actual structure were used for testing. A static load similar to furniture located in the living room was applied using sandbags.**

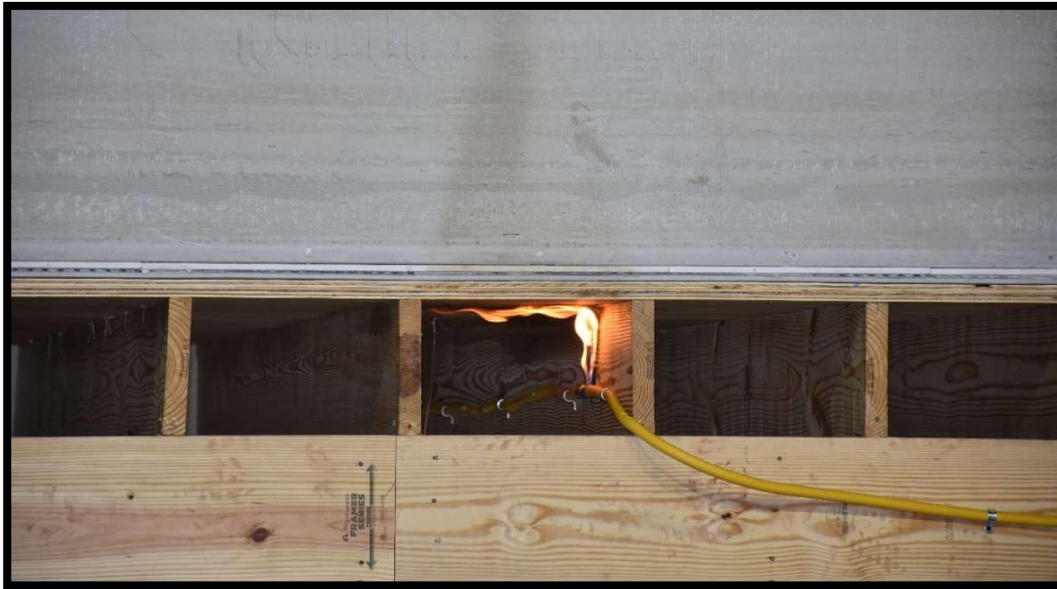
**Figure 28.** A small hole was drilled into the CSST line with similar dimensions to the actual arc hole formed by the lightning strike. Propane was then supplied to the CSST and the pressure was regulated until the flame height was similar to what was measured at the fire scene when the original propane system was field tested.

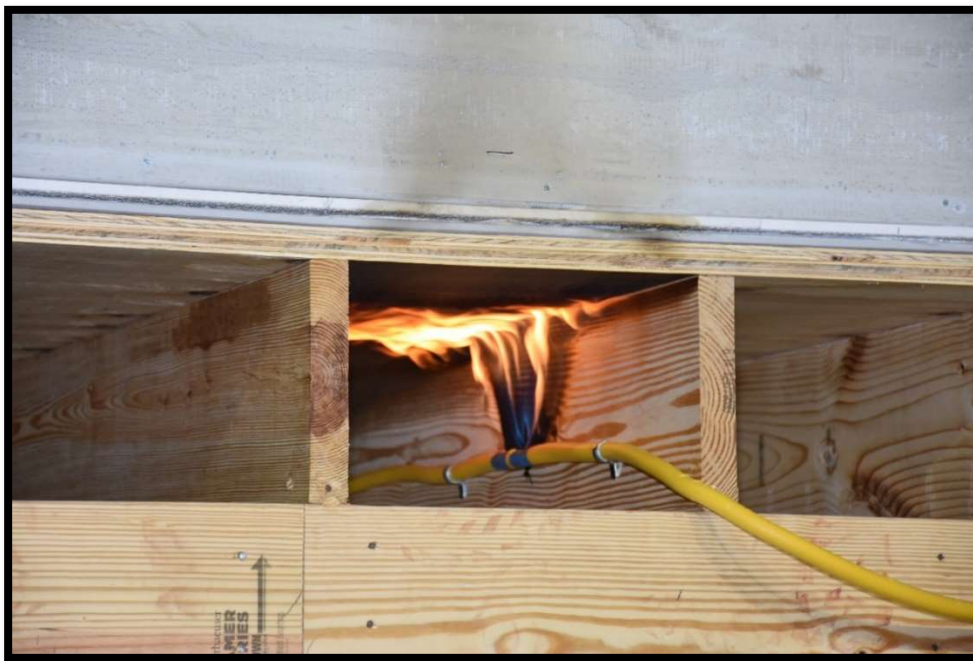
**Figure 29.** The escaping gas was ignited and flames were allowed to extend to the structural lumber.

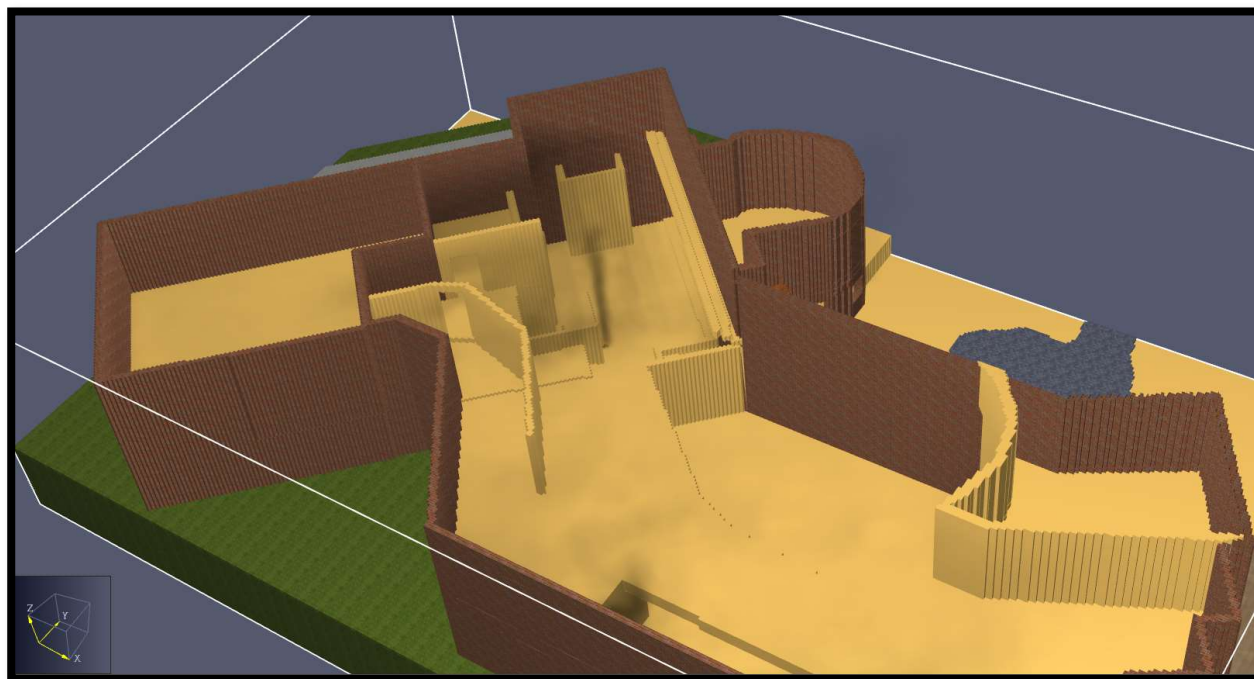
**Figure 35. Pyrosim Results image depicting smoke filling during the incipient stage of the fire. Smoke was witnessed emanating from the floor of the living room (directly above the crawl space) by the homeowners as they exited.**

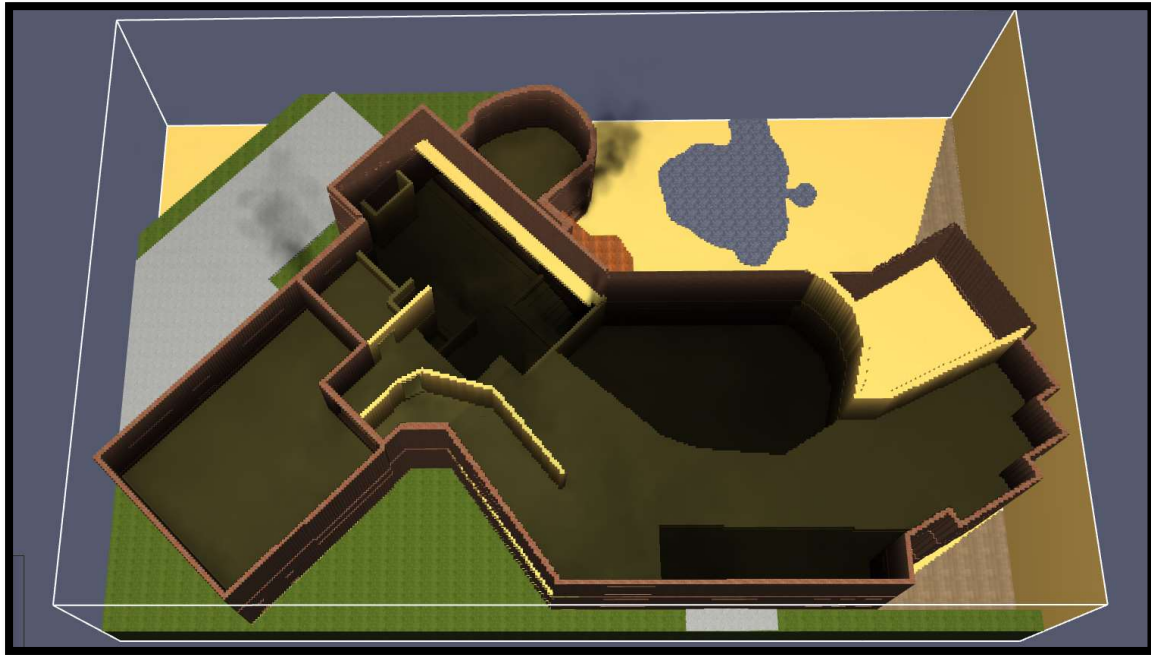
**Figure 36. Pyrosim Results image depicting the residence completely charged with smoke (on all three levels). Smoke can be seen leaking from the basement and through the open upper side C mud room door. This image is representative of conditions encountered by first arriving firefighters.**

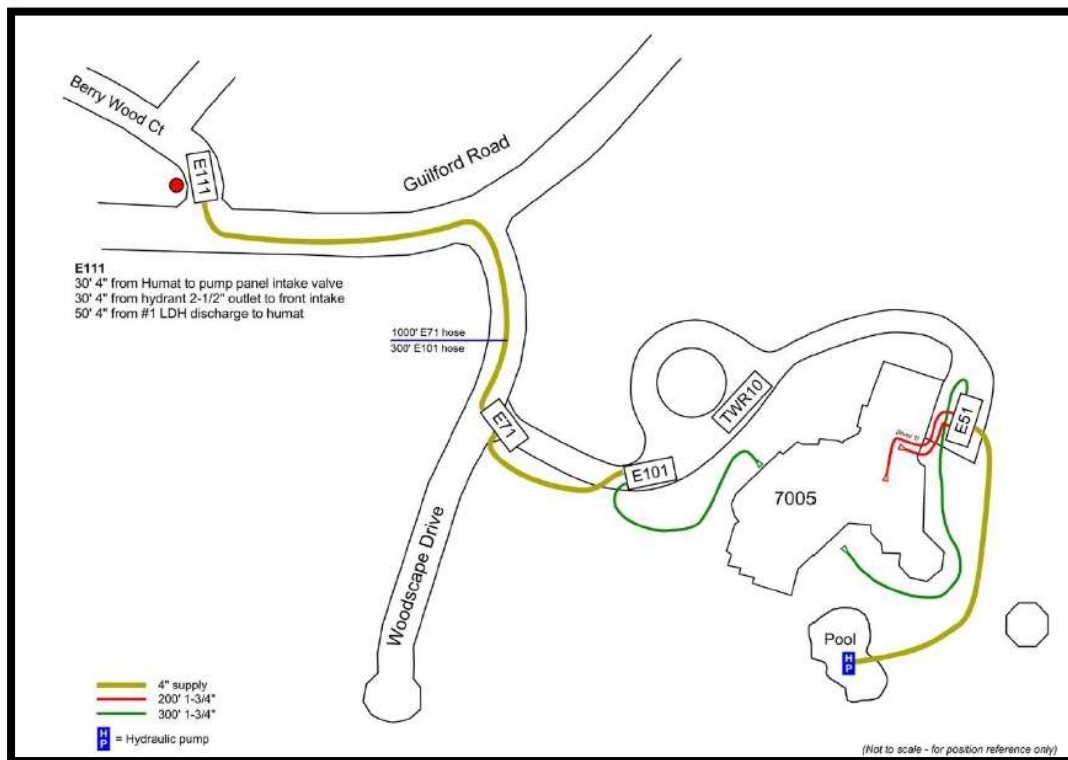
**Figure 37. Fire apparatus and hoseline (supply and) placement relative to the structure at 7005 Woodscape Drive.**

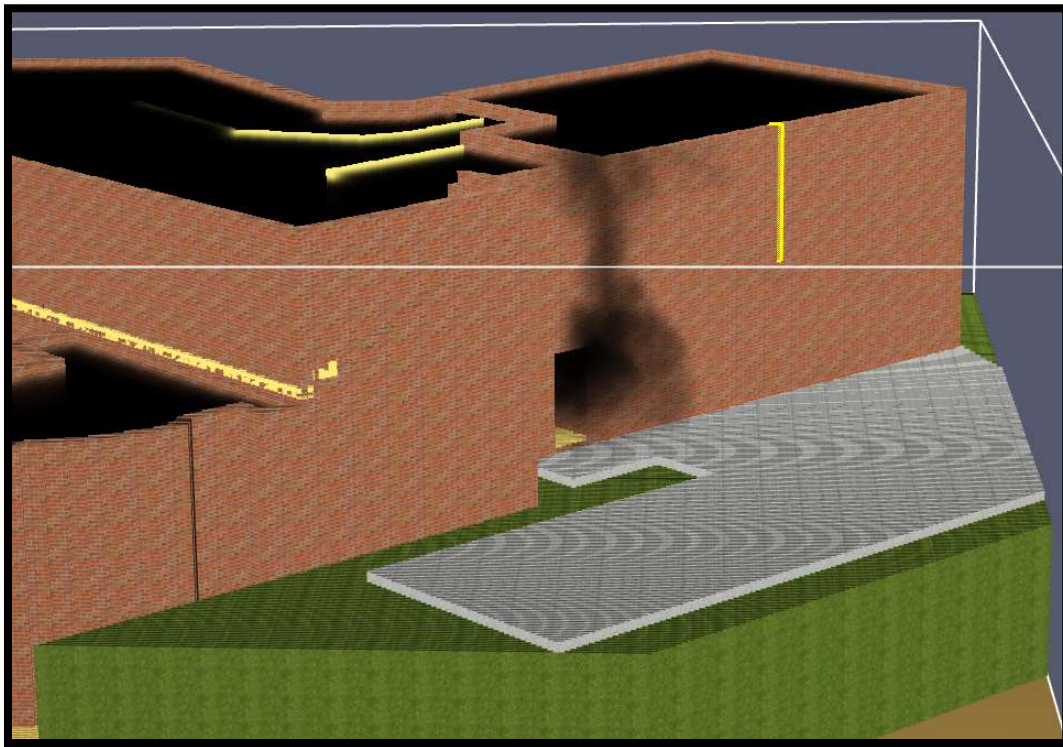
**Figure 38. Pyrosim Results image depicting smoke emanating from the mud room entrance at the approximate time of first entry by members of Engine 51. Note the bi-directional smoke flow as the basement entrance is shut at this time.**

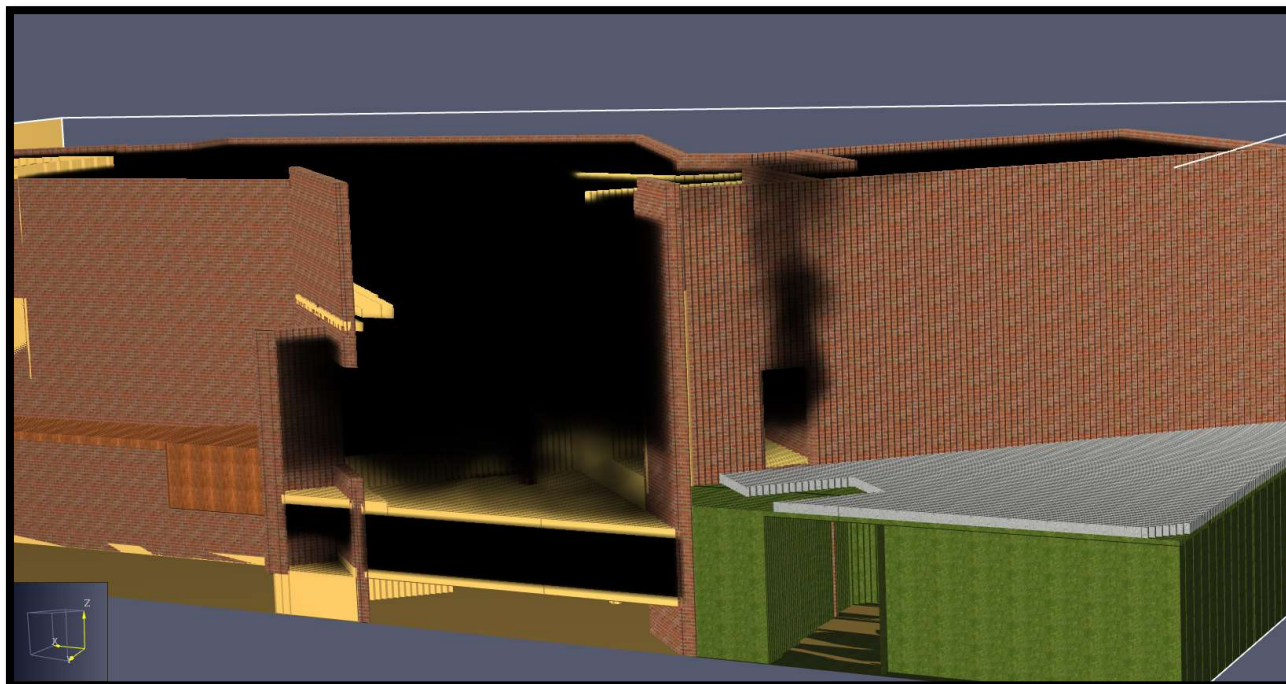
**Figure 40. Pyrosim Results image depicting smoke conditions in the basement and crawl space. Engine 51 crew members identified that the fire was likely in the basement and withdrew from the first floor to reposition to the basement entrance.**

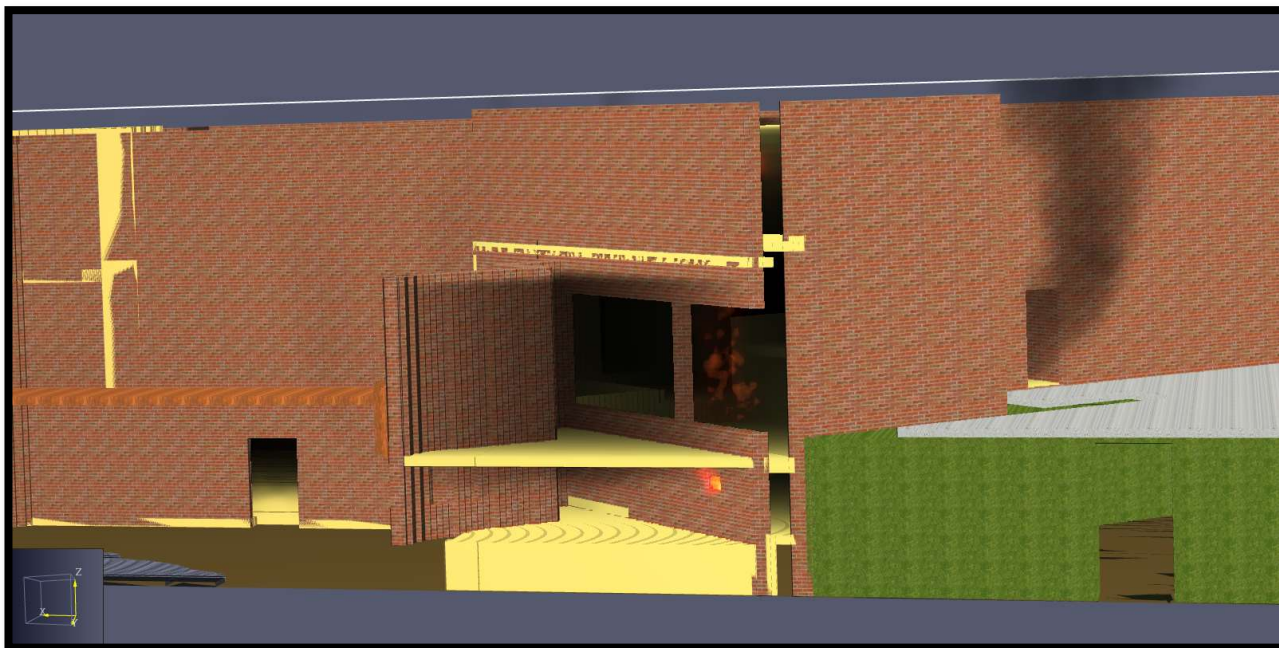
**Figure 41. Pyrosim Results image showing the smoke conditions encountered in the basement when crews first opened the basement door. Opening the basement door created a unidirectional flow path with the basement door acting as the inlet and the mud room door acting at the outlet. The influx of air caused the fire in the crawl space to intensify and spread to items on the first floor. Exterior crews now noticed flames on the first floor and believed the seat of the fire to be on the first floor.**

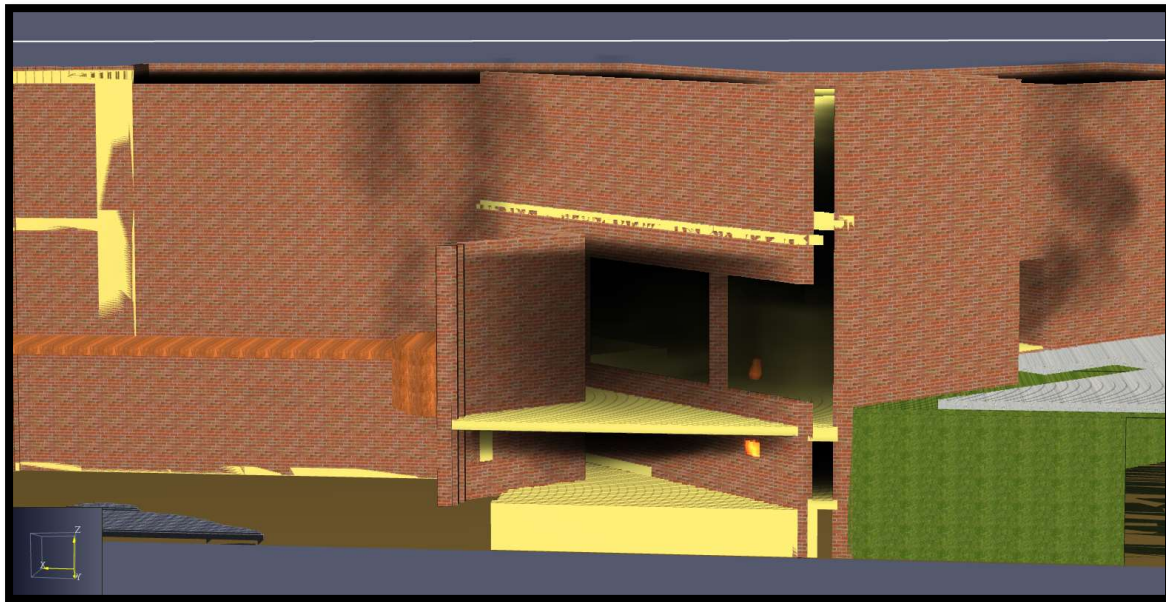
**Figure 42.** Pyrosim Results image depicting conditions when crews re-entered through the laundry room (mud room) door to attack flames seen on the first floor. Flame extension from the crawl space to the floor occurred via a hole that formed near the area of the propane leak in the CSST.

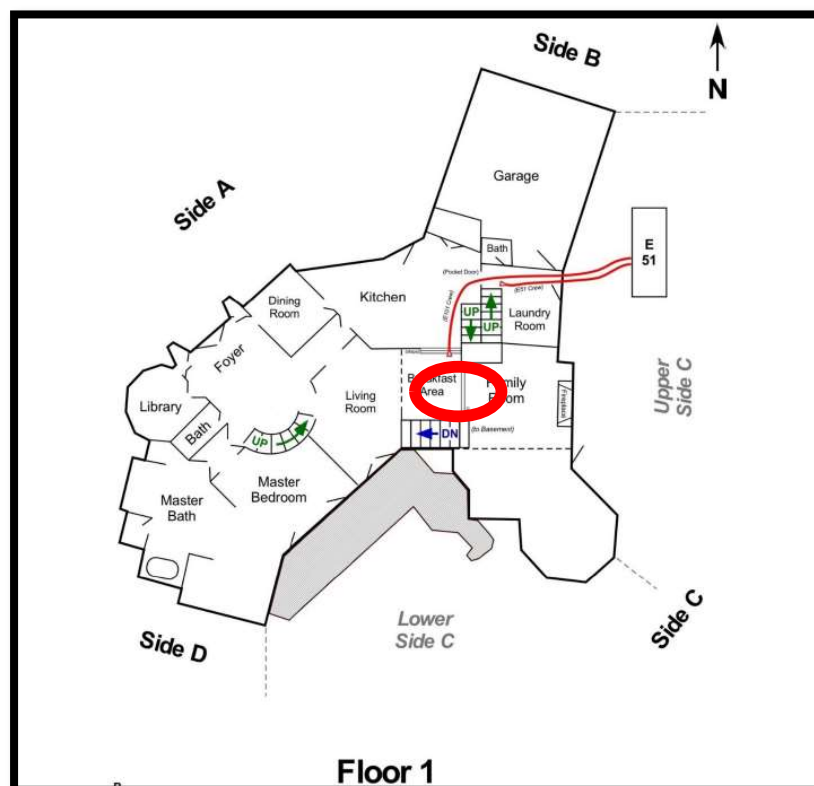
**Figure 43.** First floor diagram depicting the location of two hoselines pulled from Engine 51 through the mud room door. Firefighter Flynn falls from the first floor into the burning crawl space where the hoseline enters the

**Breakfast Area. Additional hoselines were also pulled from Engine 51 to the rear basement door (not pictured). Red circle indicates approximate location of the hole.**

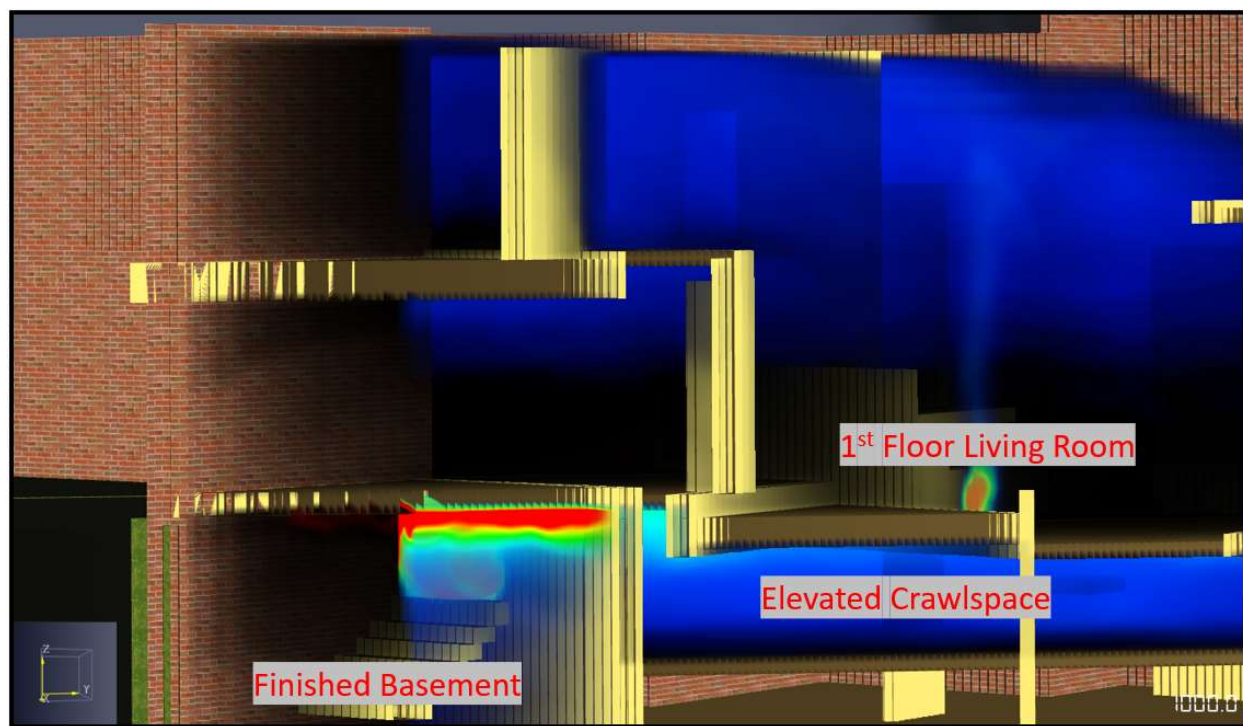
**Figure 44. Pyrosim Results image (Sectional view) depicting smoke filling and relative temperature just prior to the MAYDAY. The stairs leading up to the crawl space entrance can be seen on the left side of the image.**
